ARCHITECTURAL ASSESSMENT \ 01

The original Ely Public Library was a fire station located on Dows Street, which is a prominent thoroughfare in the City. The building was converted in 2002 into a library utilizing the fire station building, the car port, and an adjacent park shelter on a 7,000SF site. The overall library building square footage is 5,310 gross square feet.

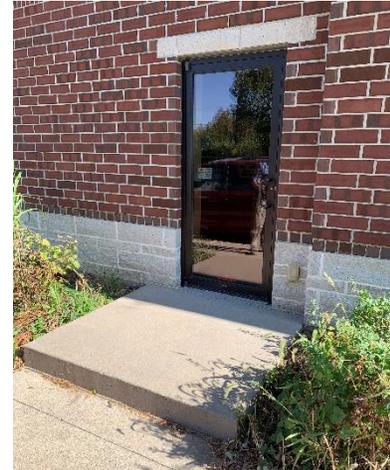
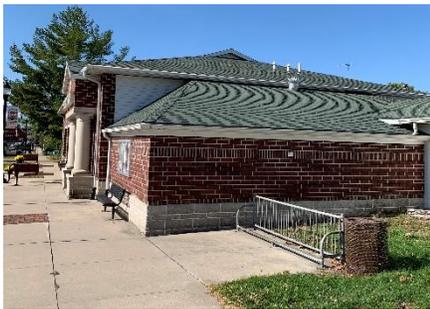
The second exit of the library, on Walker Street, contains a raised stoop. Per building code, more than half of the building exits are required to be accessible. This step should be revised to a ramp with railing.

The non-public façade comprised of masonry units, some of which are unpainted at former window locations, should receive paint or a weather barrier to prevent the opportunity for moisture to wick through the masonry. Sealant joints along this wall location are not continuous and are in need of replacement.

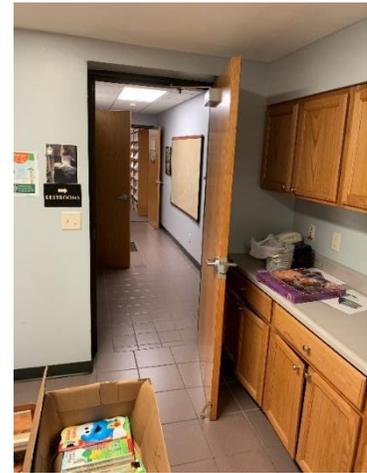
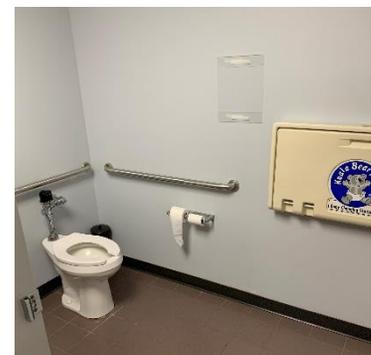
The toilet room accessories are mostly ADA accessible. A third grab bar is required for ADA compliance in the accessible toilet stall or toilet room. This grab bar would be installed vertically above the 42" bar on the wall parallel to the toilet.

The second building exit will require modification to become ADA compliant (ramped) and will require handrails on both sides at that time. The storage room floor transition is ramped and requires a handrail due to the depth of the ramp.

Signage is provided in most areas and must contain raised characters and braille. The braille does not appear to be provided.
