ARCHITECTURAL ASSESSMENT \ 01

The original Ely Public Library was a fire station located on Dows Street, which is a prominent thoroughfare in the City. The building was converted in 2002 into a library utilizing the fire station building, the car port, and an adjacent park shelter on a 7,000SF site. The overall library building square footage is 5,310 gross square feet.

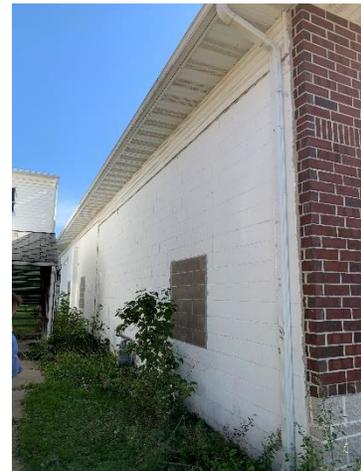
The proposed new library expansion location is off the main libraries northwest wall, into a lot that is currently occupied by a residential building. To connect the new addition to the main library, steel or masonry frames will be installed at new wall penetrations in the northwest wall. The addition's structure will be independent of the current building and consist of CMU bearing walls with supplemental steel columns and beams supporting a steel joist roof system and a metal roof deck.

Should the new addition be a two-story building, the second-floor framing will consist of precast plank with topping or composite metal deck and steel beams bearing on CMU walls. The roof structure will remain as a steel joist system and metal roof deck.

New additions to the current library will have shallow cast-in-place concrete spread footings and isolated footings at supplemental column locations. A geotechnical exploration will be required to determine the suitability of the bearing soils in the lot to the northwest and confirm the foundation types for the new addition.
